EXISTING CONDITIONS MEMORANDUM

FROM: Gene McCarthy, P.E., Project Manager, McFarland Johnson, Inc.

DATE: June 29, 2010

PROJECT: Windham NH Route 111 Corridor and Wall Street Extension Study

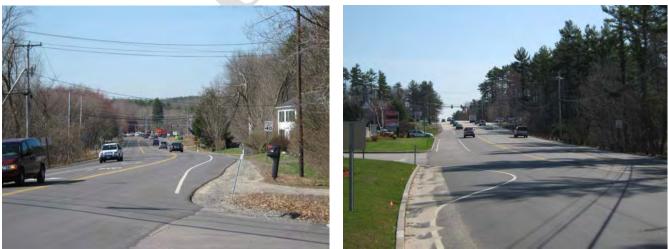
NH Route 111 Looking West from No. Lowell Road

NH Route 111 Looking East from Church Street

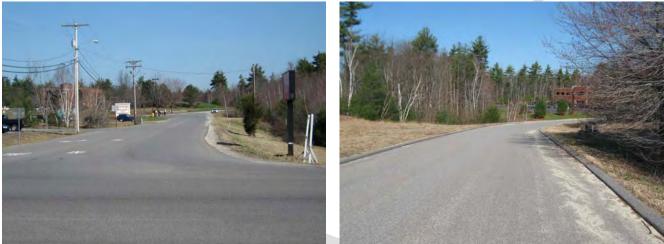
Wall Street is a dead-end local road that provides access to commercial properties. It is connected to NH 111 via a signalized intersection. Wall Street provides access to a shopping mall that includes a Shaw's supermarket, a state park and ride lot, a bank, an office building, and an industrial business via International Road. There is direct access to the shopping mall from NH 111, however, only for westbound traffic. All eastbound traffic heading to the shopping mall must use Wall Street. There is no posted speed limit along the roadway and there are no sidewalks or bike paths. The pavement is in good condition.

Looking at Wall Street from NH Route 111

Wall Street, Looking North
